Manhole Inspection Summary

Manhole # S39QQ_005MH

Insp Date: **2/28/07 8:45 AM**

Location Address: **800 BONAPARTE AVE**

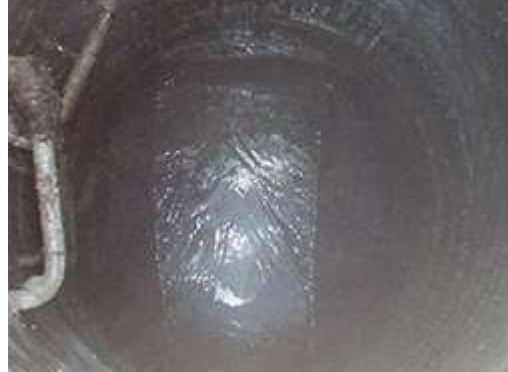
Top View

☐ Parged ☒ **Debris** (not Condition related)

☒ **Evidence Of Surcharge**

Evidence of surcharge - Bench debris.

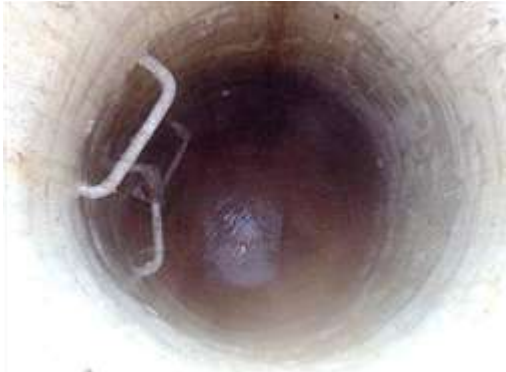
Defect

Infiltration: ☐ None ☒ **Joint** ☐ Cracks ☐ Mortar ☐ Roots ☒ **Wall**

Infiltration: ☐ None ☐ Joint ☐ Cracks ☐ Mortar ☐ Roots ☒ **Wall**

Adjustment and Corbel infiltration.

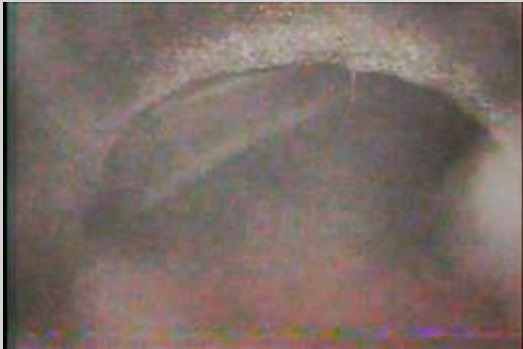
18 in. Circular Gravity Sewer Pipe Out @ 12 O'Clock

Invert Depth: **20.01** (ft.) Flow Characteristics: **Slow**

Deposits: ☒ None ☐ Mud ☐ Sludge ☐ Debris ☐ Grease

Infiltration: **None** Pipe Seal Cond: **Unknown**
